Retrofitting and waterproofing of Aged Concrete Using Electromigration of Nanosilica

Research Article

Keywords: electromigration, nanosilica, cement matrix, aged cement recovery, retrofit

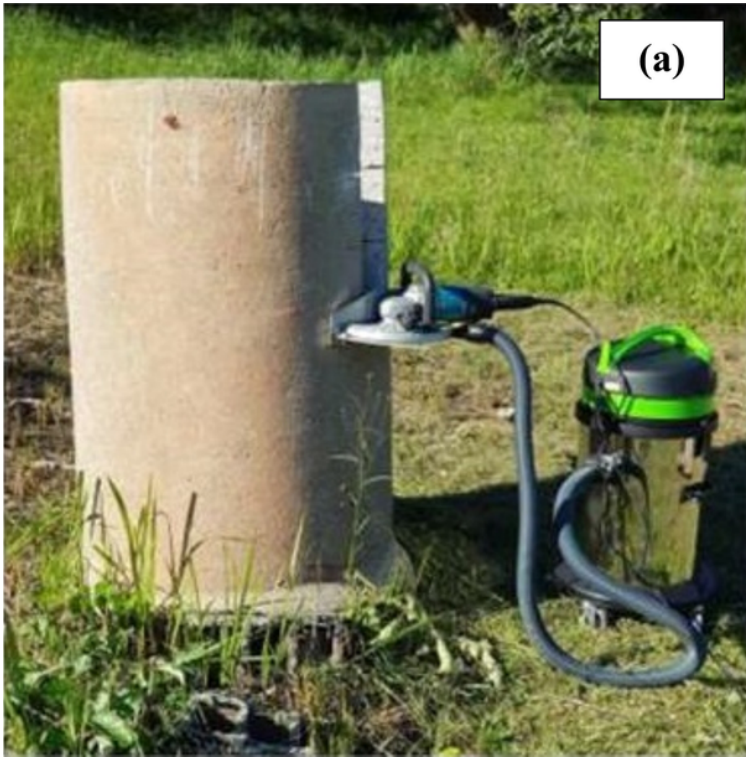
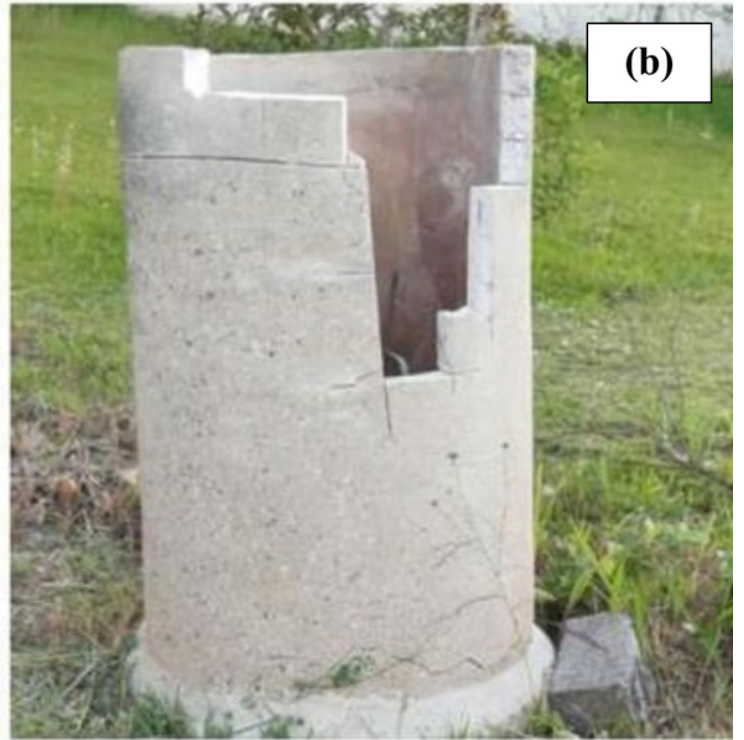
Figure 2

(a) Circular saw coupled to a dust control. (b) Structure after extraction

The concrete samples were extracted from an aged concrete structure, made in 1980. These samples were exposed to environmental factors for 40 years, such as pollution and contaminants including chlorides and sulfides. A circular saw was used to extract the samples from the existing aged concrete structure, as shown in Fig. 2. Samples were screwed to reach the dimensions of 10 cm in height, 15 cm in length and 8 cm in width, as shown in Fig. 3.

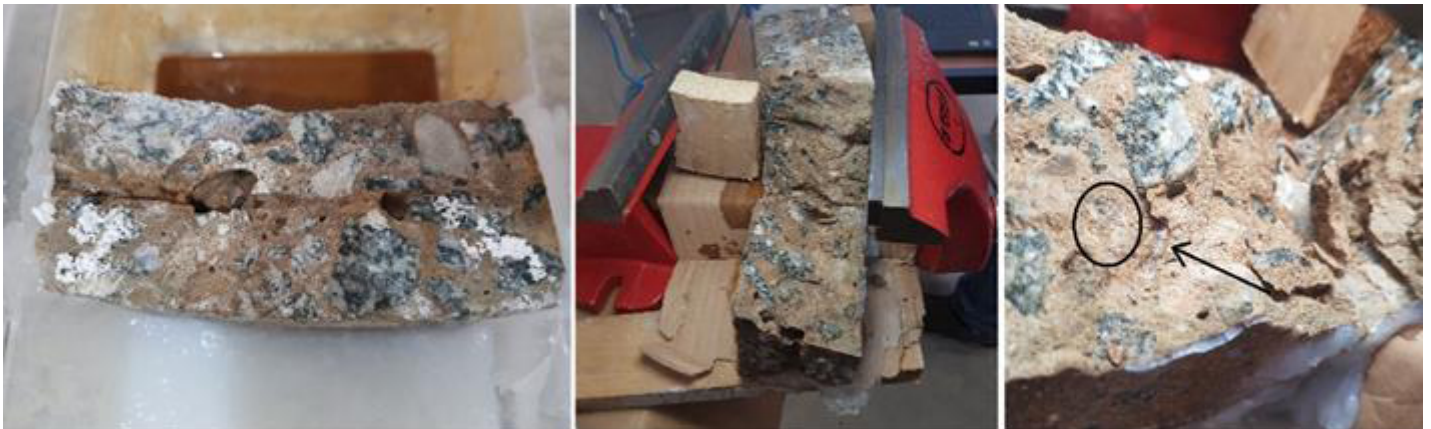
Figure 4

Mechanical shear fracture process of test 1 sample

The concrete sample was then broken by mechanical shear after the electromigration process, to ensure cement matrix preservation (Fig. 4). Qualitative analysis was made using an electronic microscope to verify Nano Silica deposition inside the cement matrix of samples. The analysis allowed validation of the electromigration process with deposition of Nano Silica inside and outside of the surface of the sample.

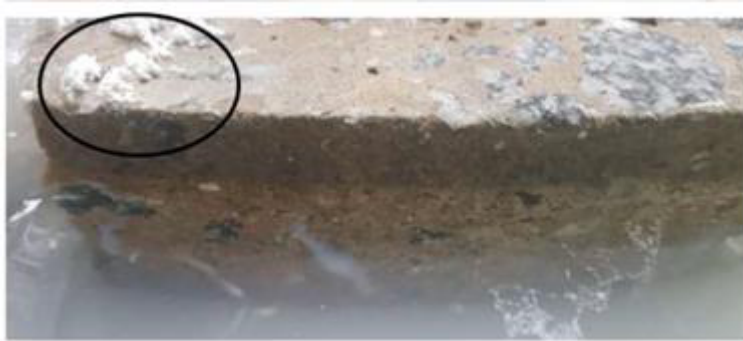
Figure 6

Silica accumulation points on the upper surface of the sample

It was found out that there was a buildup of silica on the specimen faces that were exposed to the fumed silica, with a buildup also occurring on the upper face of the aged concrete sample as shown in Fig. 6. The Nano Silica migrated to positive electrode due to its negative charge and electric field forces.

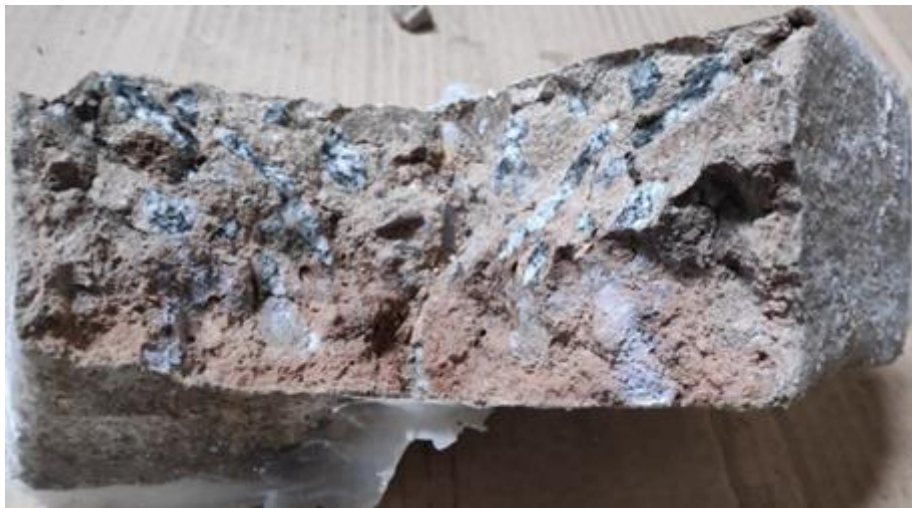
Inside of sample after test

Electronic microscope was used to qualitative analyze the inside part of the sample. To verify the electromigration process of the fumed silica, after the natural drying time, the concrete sample was broken by shear and analyzed using an electronic microscope. Figure 10 shows the inside part after the break process for visual analysis.

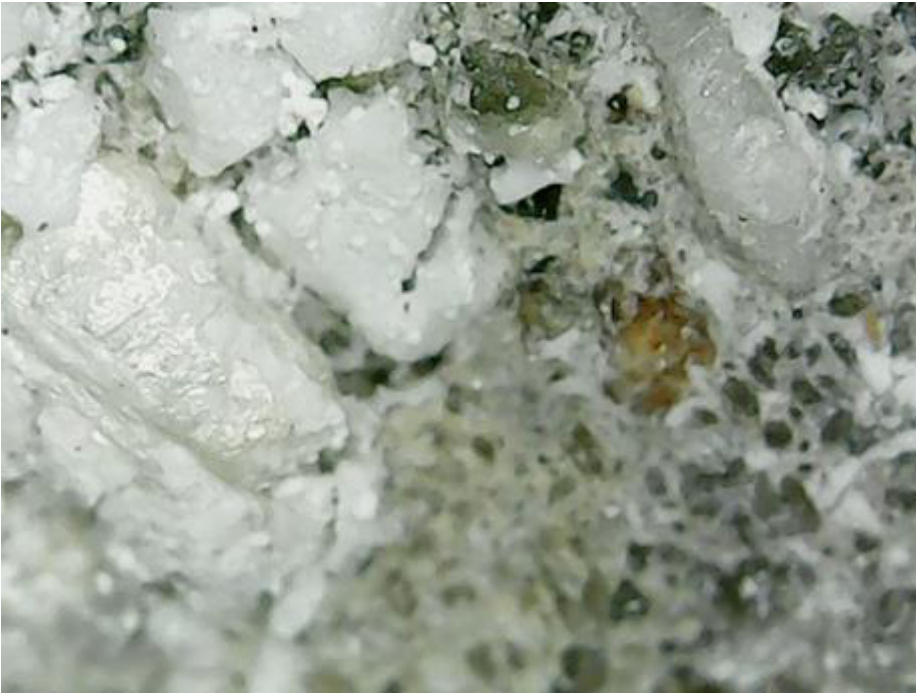
Figure 11

Fumed silica accumulation on the sample surface (1800 x magnified)

It was noticed that the silica entered more easily and in greater quantity in the cracks of the sample. With the aid of the same electron microscope, it was possible to see the surface of the part inside the crack regions in detail in Fig. 11.

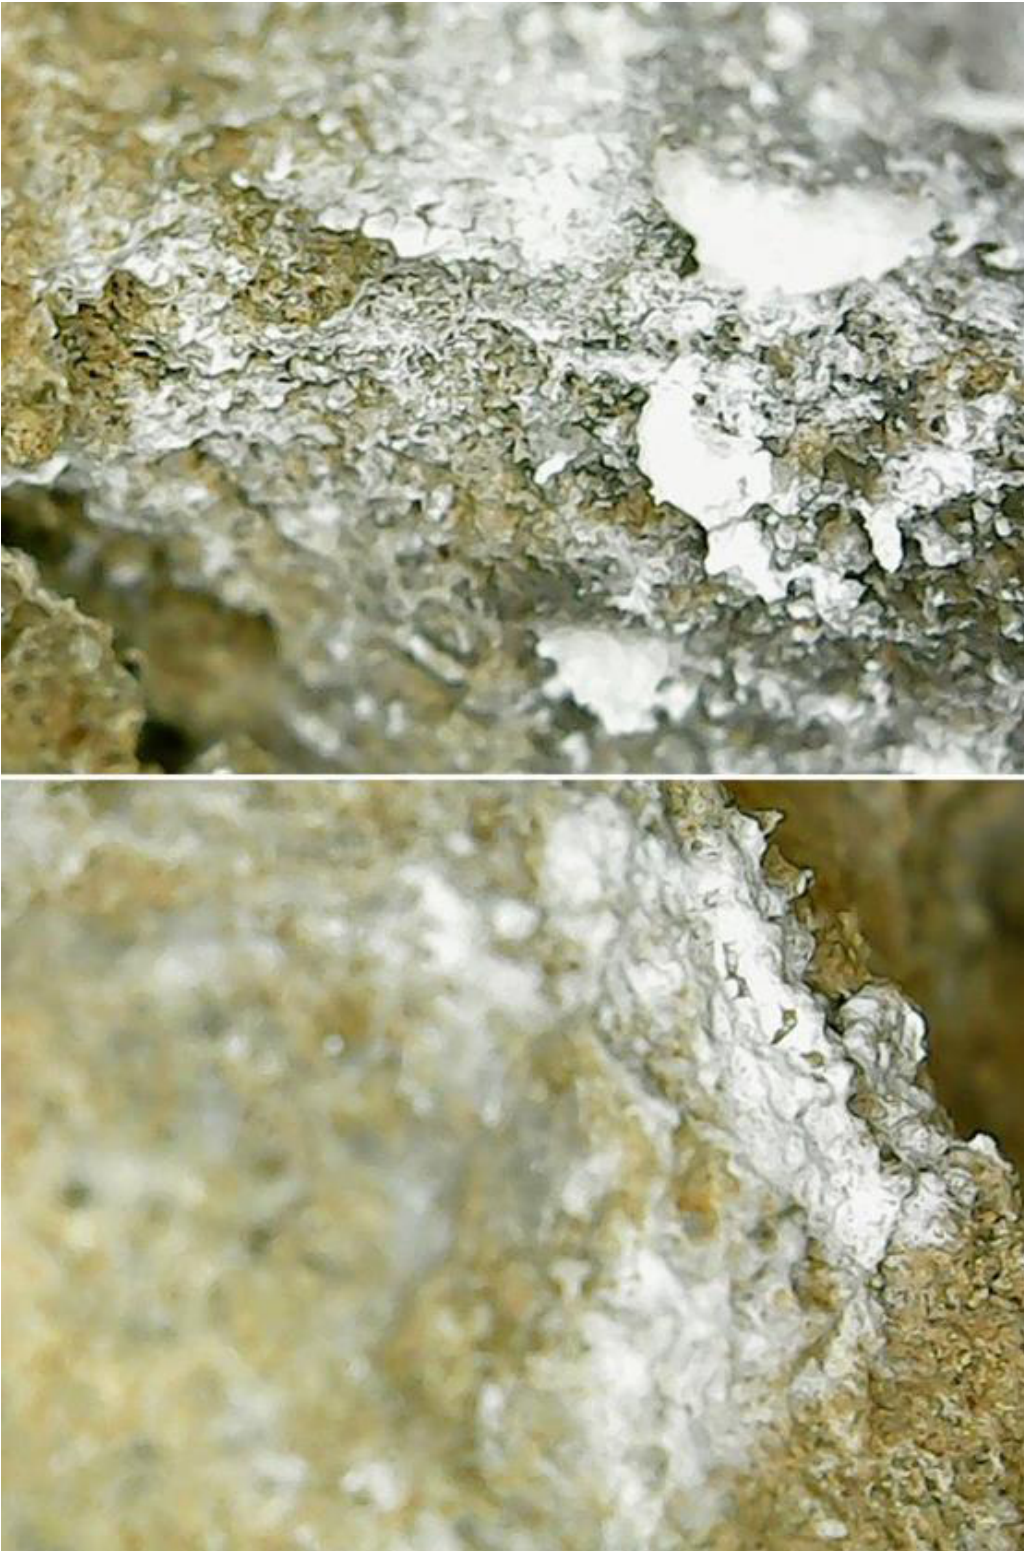
Internal accumulation of non-crystallized silica fumed (1600 x magnified)

Regarding the central part of the sample, a significant lower amount of silica accumulation was observed in the sample of Test 2, comparing to the samples of Test 1. It should be noted that the silica was dispersed in the central region of the sample, instead of in the crystallized form. The reasons for these differences mentioned are still being explored. The plausible explanation for the cause is the different force fields that were formed due to the electrodes and differences in electric potentials generated by the local power networks in Brazil (test 1) and in USA (test 2). Figure 12 shows the 1600x magnified microscopic images where the pulverized silica is in the central region of the tested concrete sample from test 2. In general, it appears that silica was accumulated on the external faces of the concrete sample and, although it has permeated the sample, there was no significant concentration in the central region. As mentioned earlier, one possible cause of the difference between the results observed in Test 1 and those in Test 2 is the type of silica used in the two tests. Nanosilica is industrially produced with purity near 100%. It can be manufactured with various desired specific surfaces areas ranging from 60 to over 600 m² /g (0.012 to 0.123 ft² /lb). Nanosilica was found to be much more efficient than microsilica for improving the durability, strength, and permeability of cement-based materials in literature (Kara and Durmus 2019). Considering that all the boundary conditions of the tests were the same, it can be inferred that the physicochemical characteristics of the Nano silica of North American supply exhibits different characteristics from that of Brazilian supply. Apparently, the current density passing through the Nano silica solution had its value decreased in relation to the Test 1. It seems that there was not electroextraction in Test 2 process. However, there was electromigration. The migration of Nano silica inside the sample was attenuated which corroborates the influence of the decrease of current density in the case of Test 2.
